Wisconsin electric co-op embraces in-house thermography

Application Note

Testing Functions Case Study

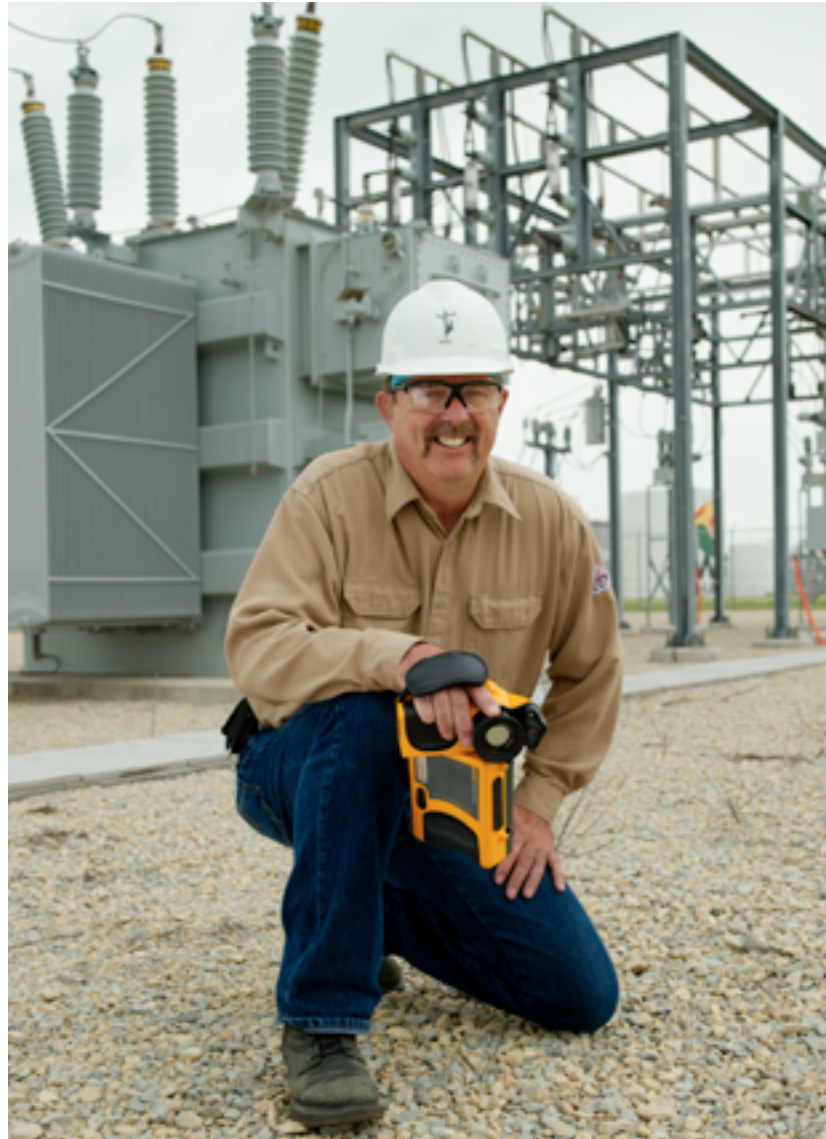
Adams Columbia Electric Cooperative monitors equipment health using thermography.

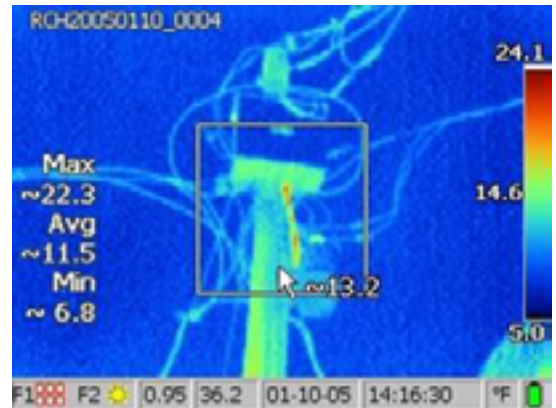
Taking a thermal image of this pole top located on a dairy farm made it easy to see that there was a problem.

To underscore the fact that most utility problems are easy to spot, Weyh reports on the inspection of one farm pole where he used the infrared camera to determine there was a problem even though the actual temperature of the pole top was outside the calibrated range of the instrument. He notified the co-op member, who contacted an electrician and scheduled repairs for the following week. Unfortunately, the pole top burned up before repairs could be made.
