Detecting problems in buildings using infrared cameras

Application Note

Testing Functions Case Study

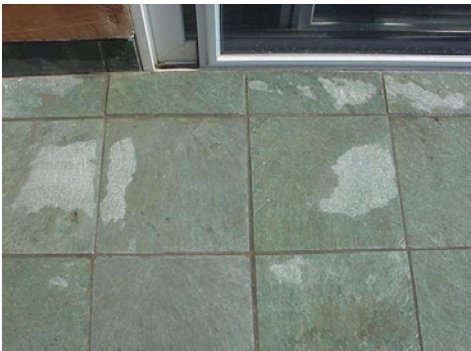
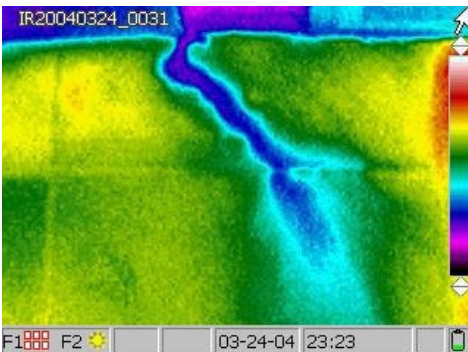
Water running underneath the tile deck into the unit below.

most cases is actually in the sub-floor and not in the floor covering itself, the temperature changes in the web sub-floor may not transfer through to the surface of the floor covering. Unwanted reflections make matters worse by distorting the true thermal pattern.

Ceramic tile

Most interior building materials have high emissive values, making them perfect candidates for thermal imaging. However locating moisture beneath ceramic tile and certain other floor and wall coverings can be difficult. Because the moisture in
