Thermal building inspections bring heating and cooling losses to light

Application Note

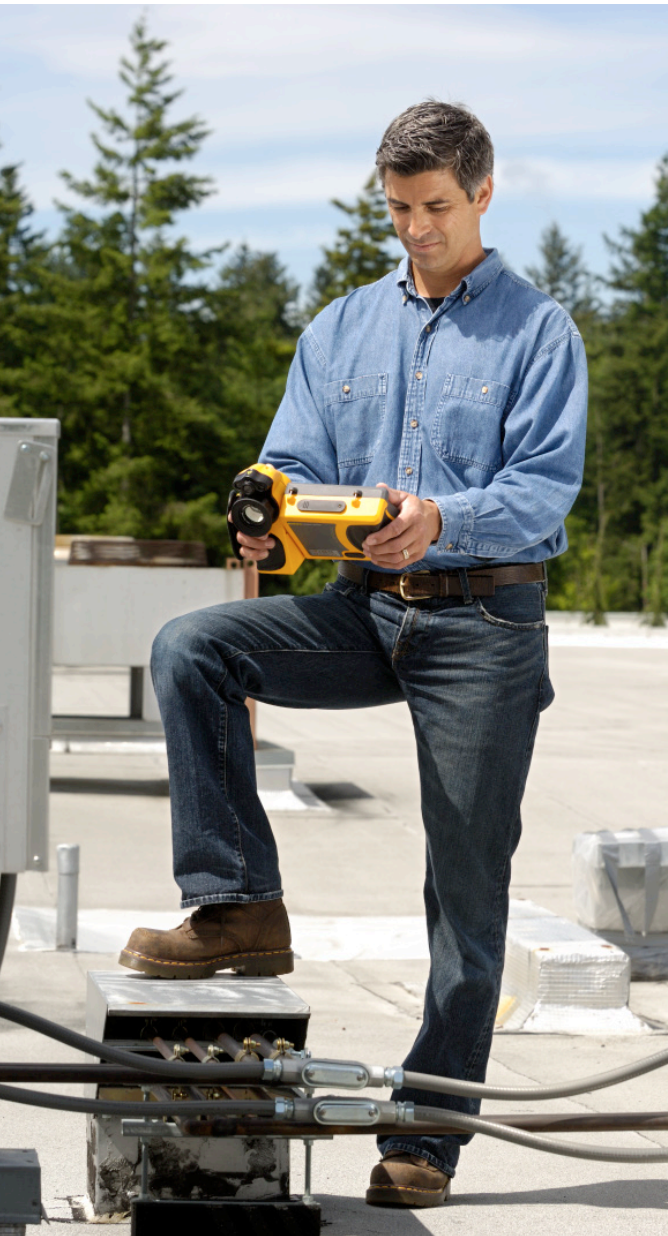
Performing a routine roof inspection to search for moisture (leaks and wet areas) in the roofing materials. **Note:** These tests are typically done at night, this photo is for marketing purposes only.

Roofs. Wet insulation is the primary cause of premature roof failures and high roof maintenance costs. Scan roofs after a hot day. Any detectable moisture will retain the heat of the day while surrounding structures and insulation cool. Nanji notes that different types of insulation result in different thermal patterns. Therefore, knowing what type of insulation is in a roof and the thermal pattern it will create in the presence of water can be very helpful in detecting moisture in a roofing system.

Nanji makes the following observations: At dusk, wet, absorbent insulation will appear thermally as a warm area, but water runs off non-absorbent insulation and collects in insulation joints. In this case, a thermal image will take on a “window frame” pattern. By contrast, foam glass block insulation will only allow water to fill in surface pores. Then, if the water freezes, it will expand and cause the insulation to crack, resulting in a “fractured” pattern.

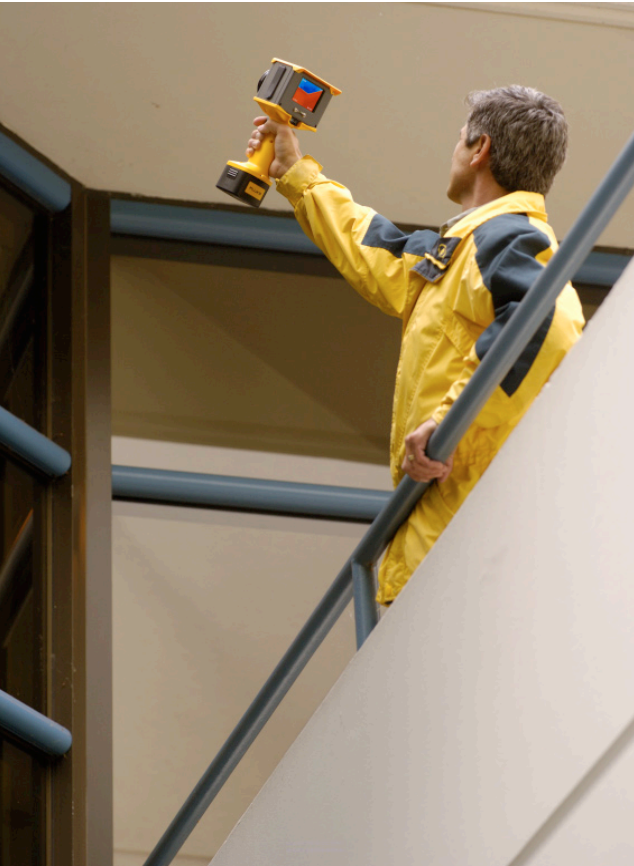
Checking for moisture within the wall surface with a Fluke InSight Thermal Imager.

Walls. During an external scan of a building under the right circumstances, a thermal imager can pinpoint moisture in walls in much the same way it can in roofs. Of course, water in walls (or roofs) will lead to mold and mildew, adversely affecting occupants who are allergic to such spores. Also, in walls (as in roofs), wet absorbent insulation will have lost its effectiveness and should be replaced. The latter situation is tantamount to a wall being partially insulated, which also will manifest itself under the right circumstances, even when moisture is not present.

Walls. Scan outside walls any time a difference in indoor and outdoor temperatures exists naturally as in winter or summer or when a significant Δt can be created artificially by elevating the output of the heating or air-conditioning system. As with roofs, when screening for moisture in walls, early morning or evening of hot days can create a significant temperature difference that will produce revealing thermal images. Of course, dusk is the best time to monitor west walls, and dawn is best for east walls. Either works for south walls in the Northern Hemisphere, but north walls may not heat up enough naturally to yield revealing thermal images.

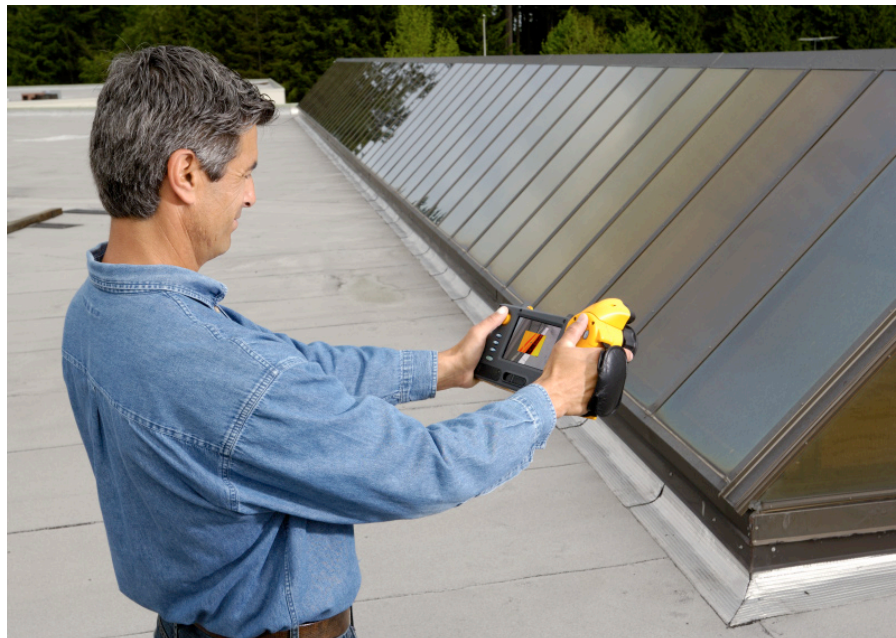
Facilities manager checks the roof flashing to make sure there is no moisture penetration.

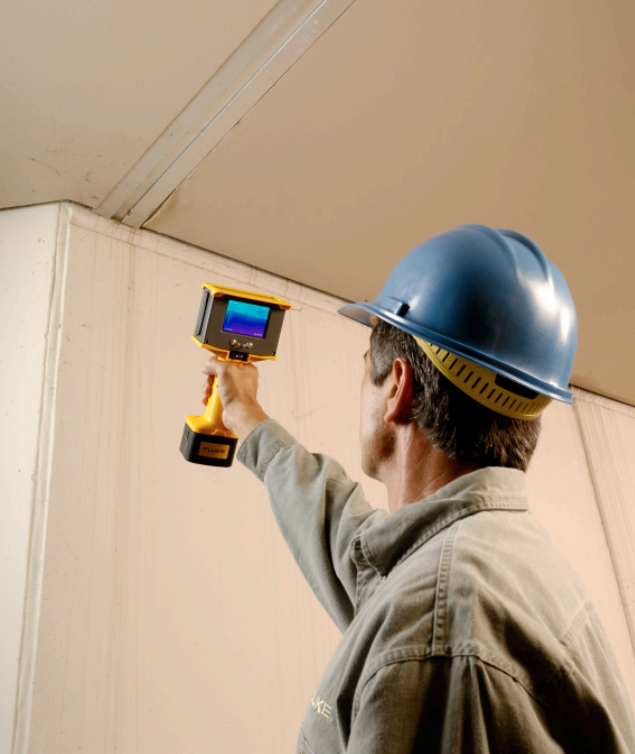
A technician checks the extent of moisture damage.
